DESIGN OF FLEXIBLE AIRFIELD PAVEMENTS FOR  
MULTIPLE-WHEEL LANDING GEAR ASSEMBLIES

REPORT NO. 1

TEST SECTION WITH LEAN CLAY SUBGRADE

TECHNICAL MEMORANDUM NO. 3-349

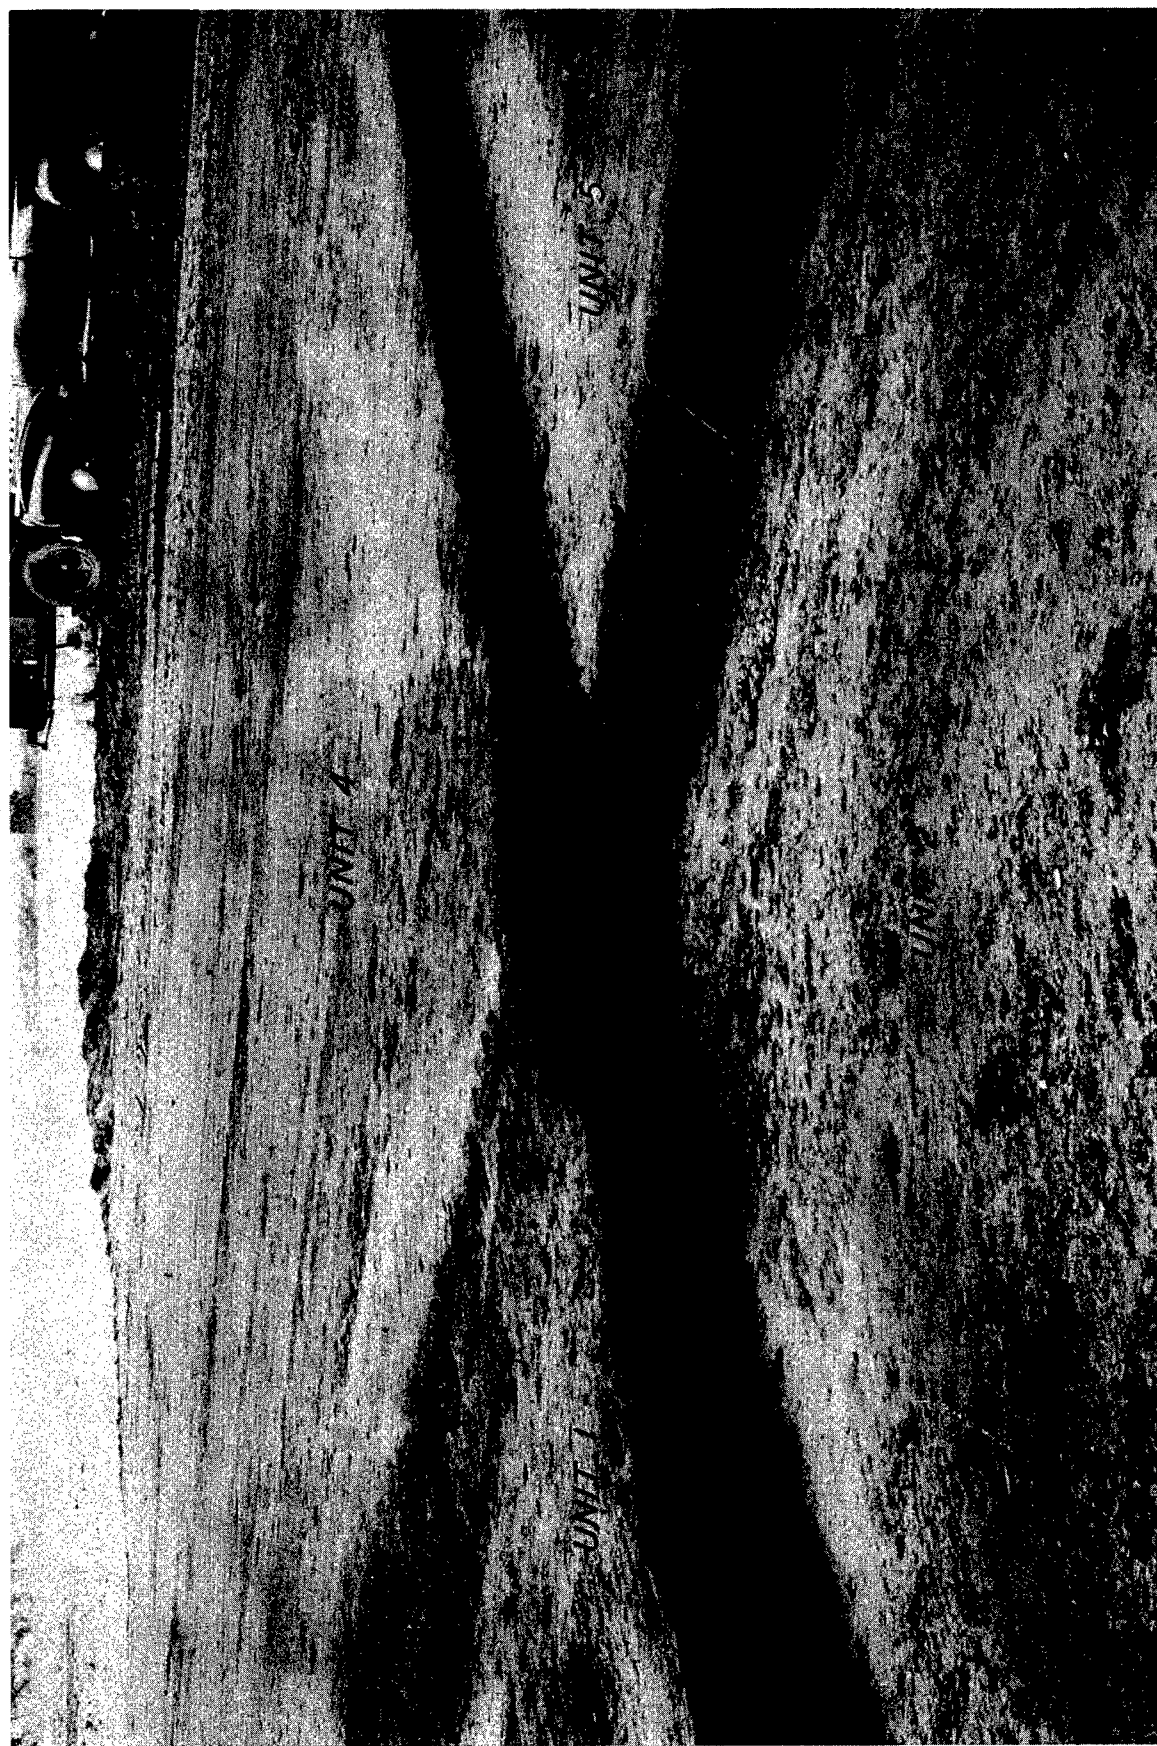
Photograph 1. View of subgrade before placing base

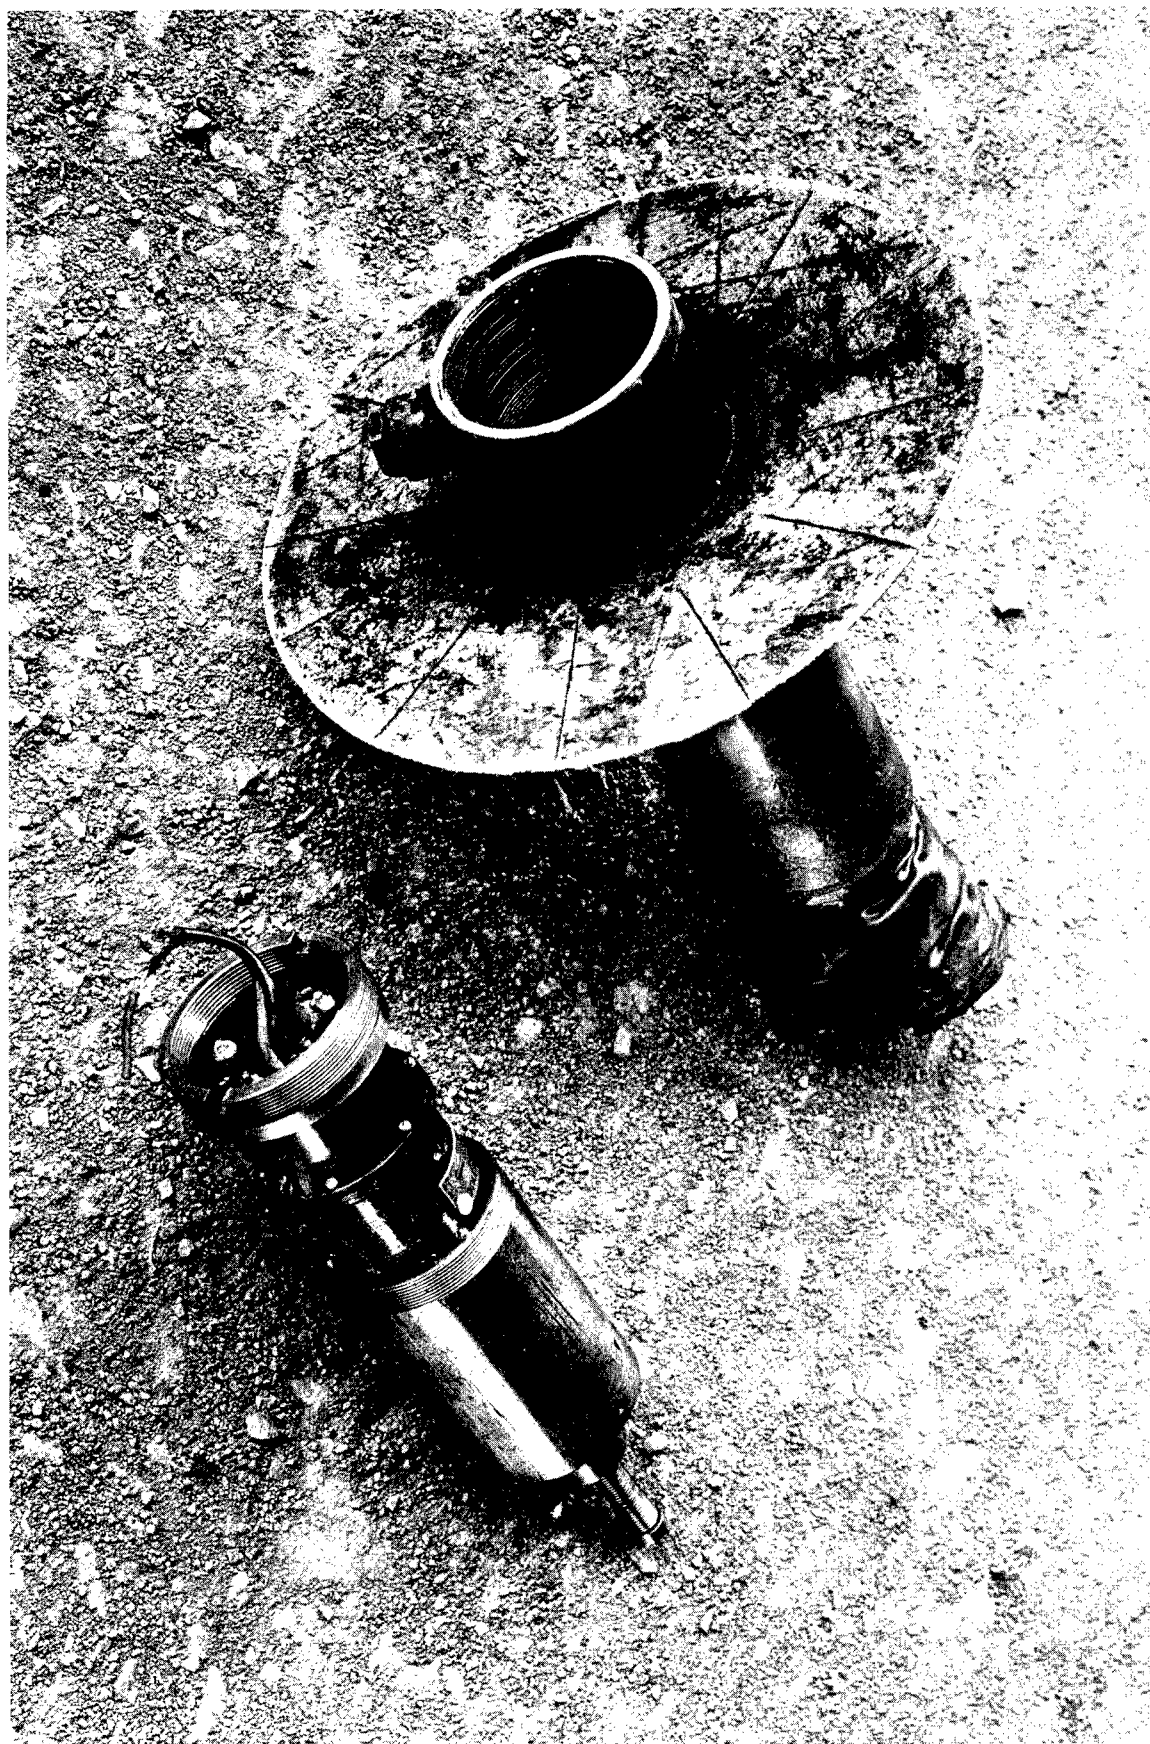
Photograph 7. View of selsyn-motor type deflection gage used in tests
